AFRL-RX-WP-TR-2011-4315

NONDESTRUCTIVE EVALUATION (NDE) EXPLORATORY DEVELOPMENT FOR AIR FORCE SYSTEMS

Delivery Order 0001: Quick Reaction NDE and Characterization--Effects of Chemical Etching after Pre-Inspection Mechanical Cleaning on Fluorescent Penetrant Indications of Fatigue Cracks

AUGUST 2011 Final Report

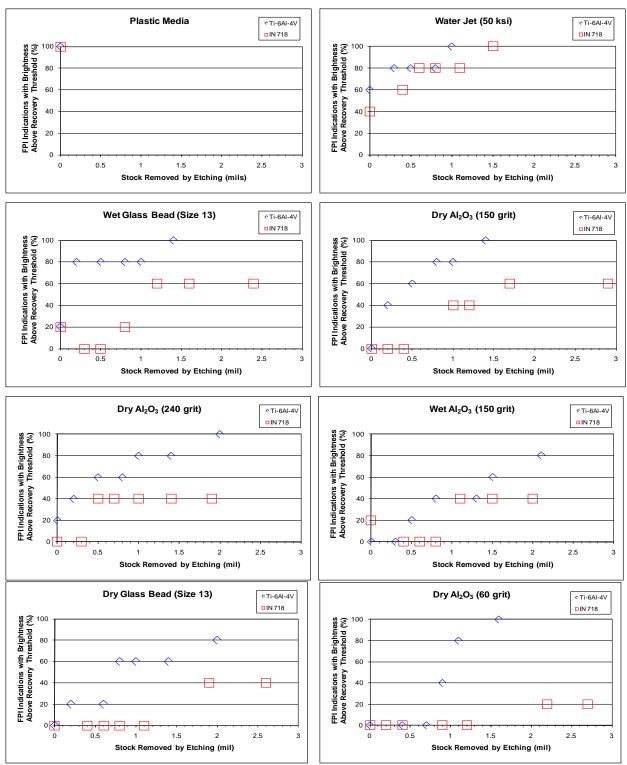
Figure 6. Post-Etch FPI Indications with Brightness above 40 Percent of Pre-MechClean

Figure 6 presents the data graphically, showing recovery rate for each etch cycle. The post-MechClean results relative to the recovery threshold are also included. Two post-MechClean indications in Inconel specimens, one each cleaned with wet glass bead and wet 150-grit Al₂O₃, suffered significant reductions in brightness after the respective initial etches, only to recover brightnesses equal to or much greater than their post-MechClean brightness after additional etching. Etching sometimes degraded FPI indications, but usually not to this degree.

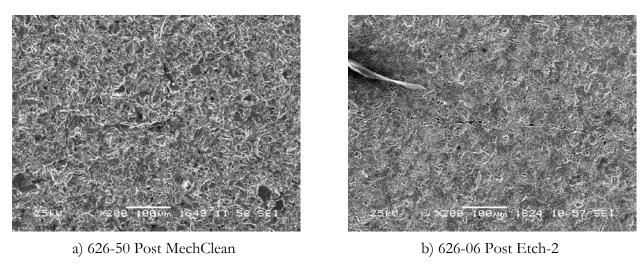
Figure 17. SEM Images of Inconel Specimens Cleaned with Dry Al₂O₃ (150 grit)

Figure 17 contains SEM images of two specimens. After Etch-2 the SEM examination could not detect the crack in 626-50, so an image of the crack in 626-06 was substituted.

Microscope images of the cracks in this group offer little in the way of clues to explain the FPI data. As with other Inconel specimens the cracks were difficult to resolve. A 600X SEM backscatter image was substituted in Figure A-48b because good optical image for 626-53 of the crack could not be obtained. In Figure A-46c a higher magnification, optical-microscope image of 626-06 shows the angular nature of the surface roughness remaining after six etches hints of foreign material inside the crack, probably cleaning media. Similar images were obtained for other specimens cleaned with the different Al₂O₃ media. Thorough evaluation of the composition of the material was beyond the scope of this effort.

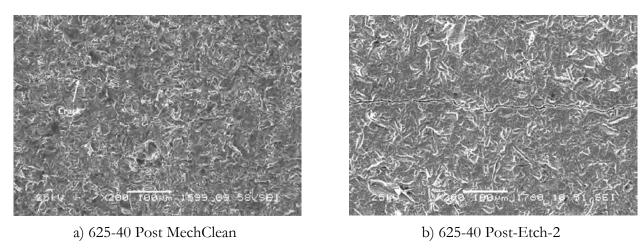
Figure 18. SEM Images of Titanium Specimen 625-40 Cleaned with Dry Al₂O₃ (240 grit)

Figure 18a shows the barely visible crack on the roughed surface of 625-40, which give credence to the dim, spotty post-MechClean FPI indication (Figure A-54a). However, after two etches removed 0.5 mil of stock, the corresponding SEM image (Figure 18b) depicts a clearly defined crack as does the optical-microscope image (Figure A-54b). The recovered FPI indication is shown in Figure A-54a.

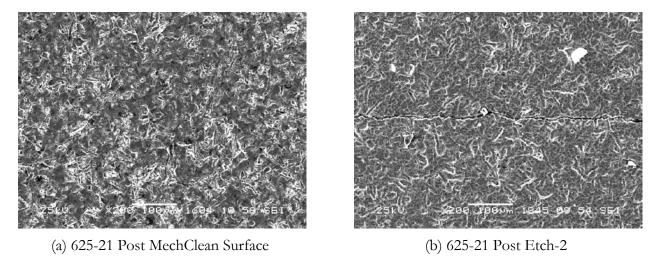
Figure 20. SEM Images of Titanium Specimen 625-21 Cleaned with Wet Al₂O₃ (150 grit)

Figure 20a illustrates the rough post-MechClean surface of specimen 625-21, on which the longest crack (0.098 inch) of the group was not visible. Figure 20b shows the crack after the second etch. It produced a reasonable FPI indication that was 27 percent of pre-MechClean brightness (Figure A-61). After one more etch the indication recovered 45 percent of its pre-MechClean brightness, a percentage that probably would have been higher if the photometer field of view had been large enough to encompass the entire crack since the ends of the indication were brighter than the center (Figure A-66a). The crack in the other specimen (T-27) examined with the SEM after Etch-2 appeared slightly wider than the one in 625-21 but produced a barely detectable indication (Figure A-61). In Figure A-65b the crack in T-27 appears significantly wider after it had been etched six times, but its indication recovered its brightness. A third, relatively short (0.035 inch) crack in specimen 625-10 recovered 93 percent of its pre-MechClean brightness after Etch-2, more than enough for it to be considered a recovered indication. Like the crack in 625-21, it was also quite narrow (Figure A-63b).

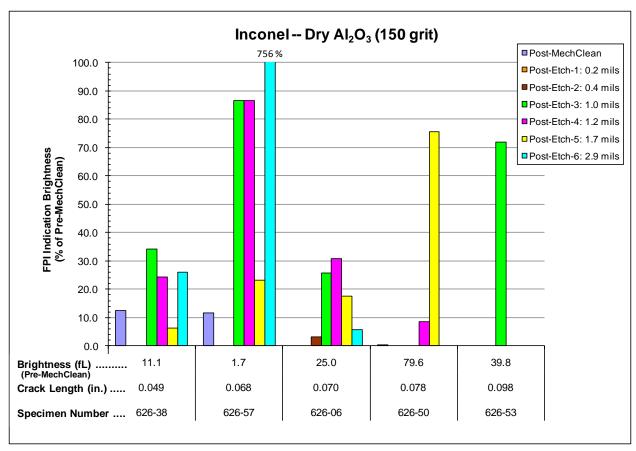
Figure A-43. FPI Data for Inconel 718 Specimens Cleaned with Dry Al₂O₃ (150 grit)

Figure A-43 shows that only one FPI crack indication (626-57) regained 100 percent of its pre-MechClean brightness. In fact, after the sixth etch the indication brightness jumped to 756 percent of its original value. That high percentage is a little deceiving because the pre-MechClean brightness was only 1.7 fL. It is not unprecedented for a crack 0.068 inch long to have such low indication brightness, but generally one would expect a higher value. For example, the pre-MechClean brightness of the 0.078-inch crack in 626-50 was 79.6 fL. Therefore, although the indication for 626-57 exceeded the 40-percent recovery threshold after Etch-3, this specimen was etched six times to see if the indication brightness would improve significantly. Indeed, this occurred, but the final indication brightness was only 13.1 fL, only slightly brighter than the pre-MechClean indication for the 0.049-inch crack in 626-38.
